July 5, 1973

SUBJECT: 1055 (G-10) CHOKE CABLE

SERVICE BULLETIN

237

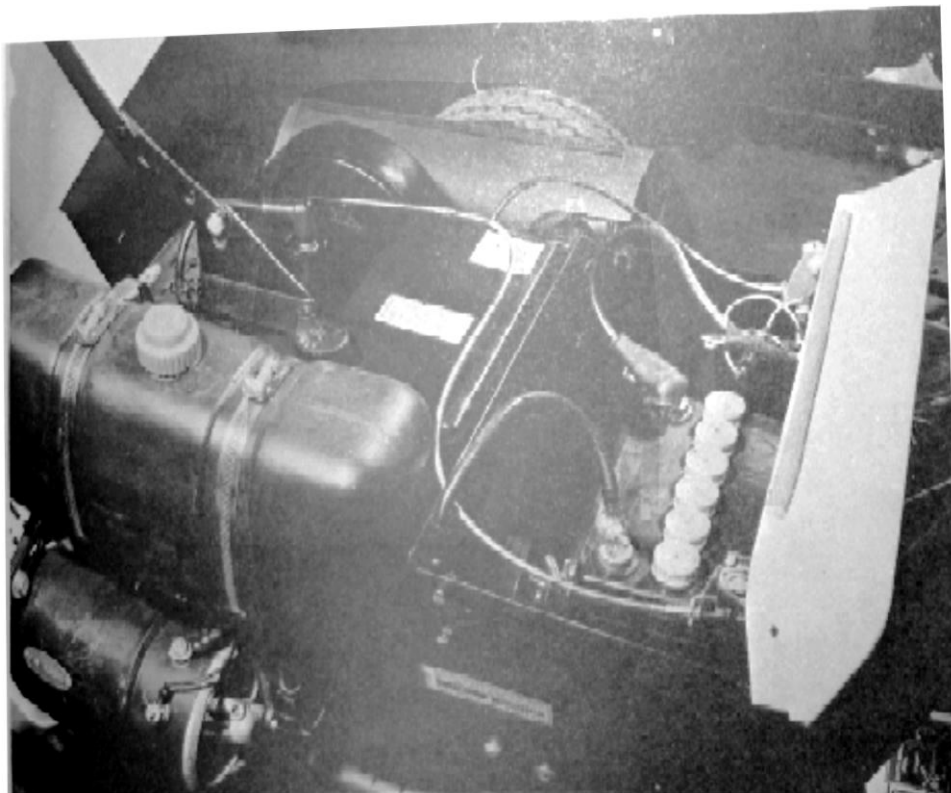
On some units, the choke cable may have been installed incorrectly on the above model tractor. This cable may have been routed underneath the heat shield. Heat from the engine exhaust pipe then may cause the choke cable to become hard to operate or function properly.

If you receive complaints, or have units in stock, check the routing of the cable and reinstall as shown in the photo. Check operation of choke plate so that a full open and closed position is obtained.

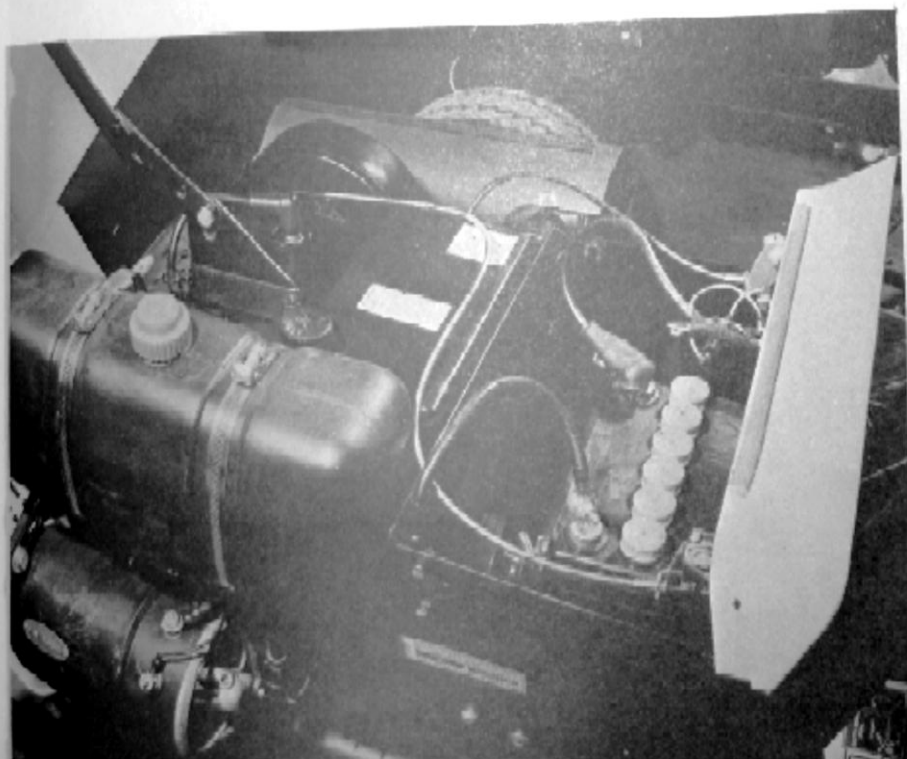
On some units, the choke cable may have been installed incorrectly on the above model tractor. This cable may have been routed underneath the heat shield. Heat from the engine exhaust pipe then may cause the choke cable to become hard to operate or function properly.

If you receive complaints, or have units in stock, check the routing of the cable and reinstall as shown in the photo. Check operation of choke plate so that a full open and closed position is obtained.
